Lower Little Wenatchee River Reach Assessment & Restoration Strategy

March 22, 2024

Lower Little Wenatchee River Reach Assessment & Restoration Strategy Report

Inter-Fluve
501 Portway Ave., Suite 101
Hood River, OR 97031

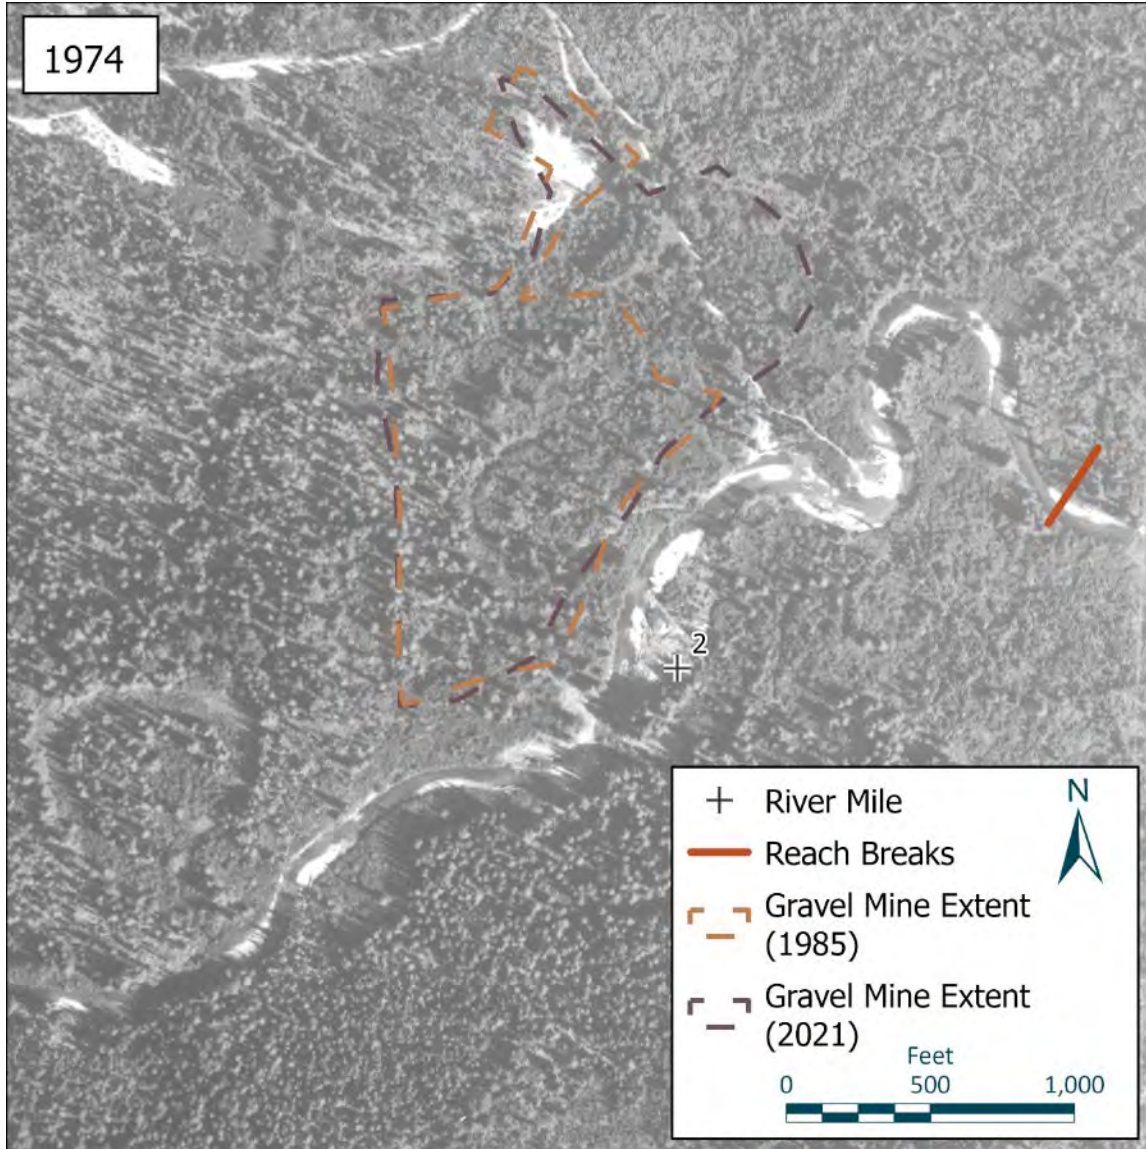
Figure 6. Aerial imagery from 1974 showing the location of a gravel mine near River Mile 2 on the Little Wenatchee River prior to its development.

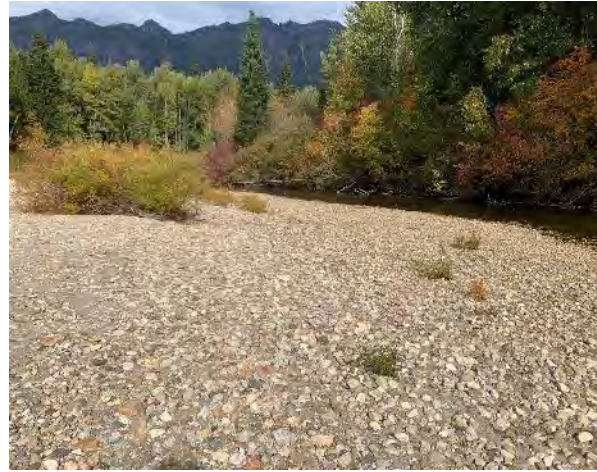
Figure 21: Reach 2 (RM 2.2) pebble count data and photo of sample location.

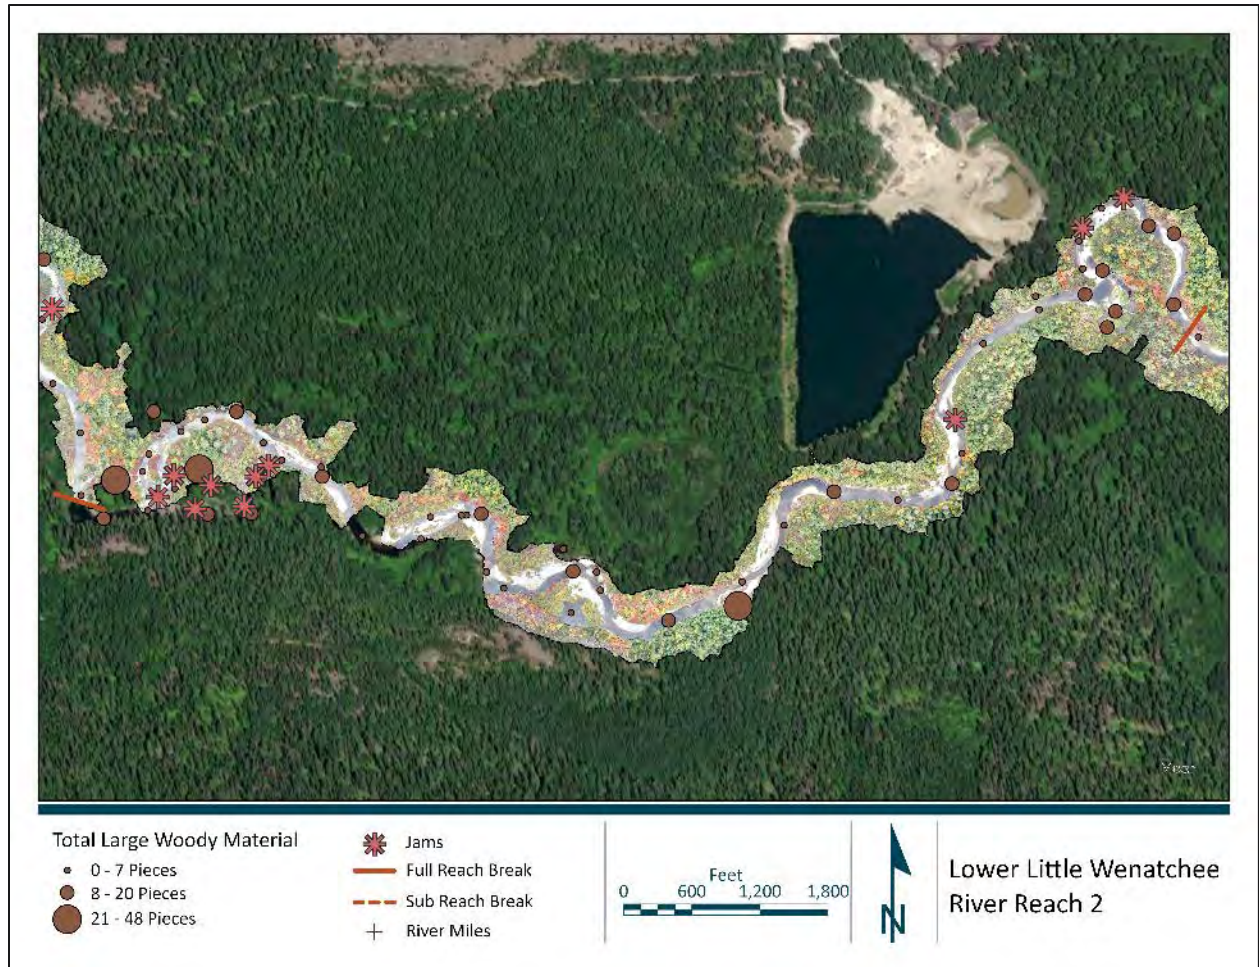
Figure 22. Large woody material observed in Reach 2 summarized by count of qualifying large wood pieces per channel habitat unit. LWM counts include all small, medium, and large size classes of wood.

Reach 2 contained the greatest number of LWM pieces in the assessment area with 410 pieces (Figure 22), or approximately 264 pieces per mile. Over a third of those pieces were “quality” large wood: large wood pieces that fall within the “medium” and “large” size classes (“medium” is considered at least 12 inches in diameter and at least 35 feet long; “large” is considered at least 20 inches in diameter and at least 35 feet long). The dominant overstory class in Reach 2 was exclusively classified as large trees, mixed coniferous (Western red cedar) and deciduous (cottonwood). The dominant understory in Reach 2 was comprised of 50% sapling/pole (DBH = 5.0 – 8.9 in.) and 50% shrub/seedling (DBH = 1.0 – 4.9 in) size classes, with a wide variety of understory species observed. Vine maple accounted for 50% of understory species, and willow, dogwood, cottonwood, and alder each made up 13% of the dominant understory species within the riparian zone of Reach 2.

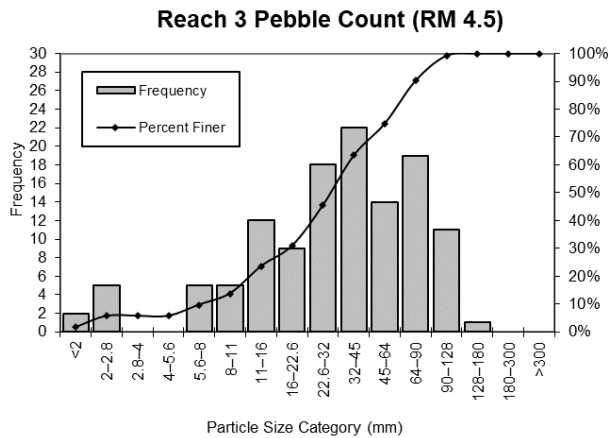
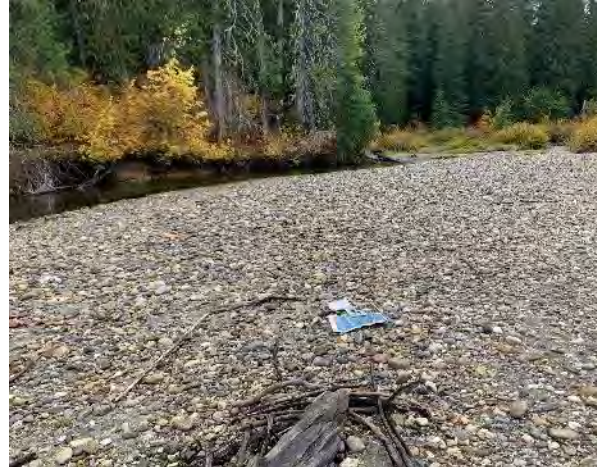
Figure 25: Reach 3 (RM 4.5) pebble count data and photo of sample location.

The reach is in a stable sediment transport equilibrium within the continuum of local meander bend processes and anastomosing channel processes. Figure 25 displays pebble count data and a photo from a representative bar surface in the reach. Within the larger geomorphic processes described above, localized large wood habitat exists throughout the reach. Habitat created by large wood is found within meander bends and on some gravel bar surfaces.

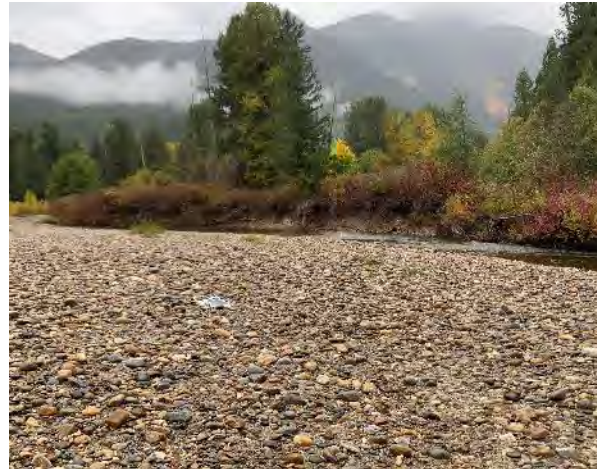
Figure 29: Reach 4 (RM 5.7) pebble count data and photo of sample location.

The reach is in a stable sediment transport equilibrium within the continuum of local meander bend processes and anastomosing channel processes. Figure 29 displays pebble count data and a photo from a representative bar surface in the reach. Within the larger geomorphic processes described above, localized large wood habitat exists throughout the reach. Localized habitat created by large wood is also found within meander bends and on some gravel bar surfaces.

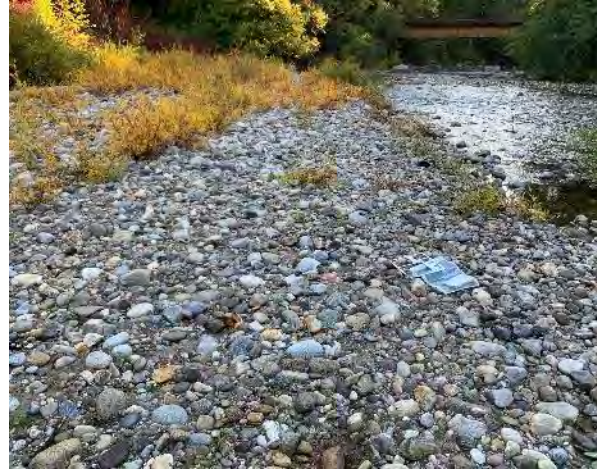
Figure 37: Reach 6 (RM 8.7) pebble count data and photo of sample location.

Reach 6 includes a bedrock canyon that is impassible to all fish species. The channel runs over bedrock and can readily transport alluvial sized substrate and smaller sized wood that may enter the channel. Upstream of the USFS 6500 bridge the channel has characteristics similar to those found in Reach 4. Channel spanning large wood deposits have developed and a complex anastomosing channel pattern exists upstream of the last assessment unit. The alluvial channel segment upstream of the bedrock canyon is in a stable sediment transport equilibrium within the continuum of anastomosing channel and large wood processes. Figure 37 displays pebble count data and a photo from a representative bar surface in the reach.

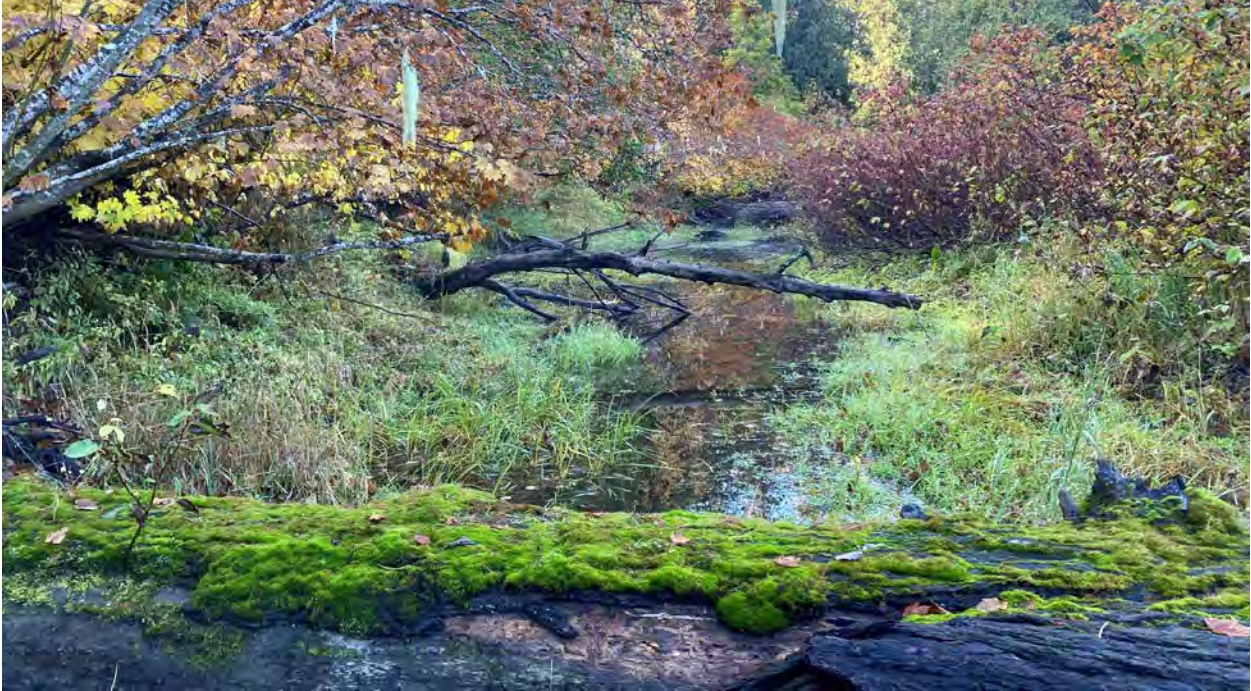
Figure 3. Side channel observed in Reach 2 with large woody material.

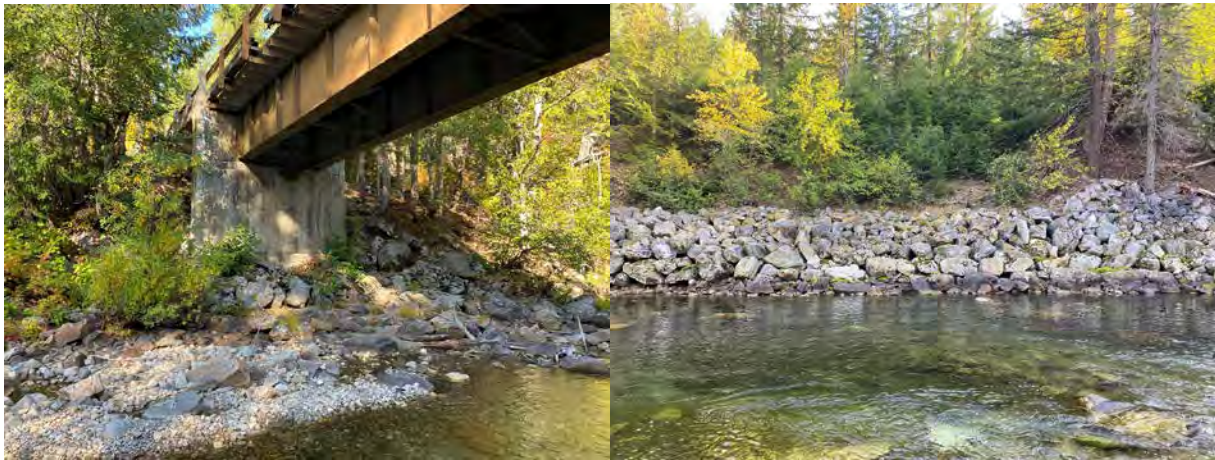
Figure 6. Left: Riprap material around the Little Wenatchee Road bridge crossing in Reach 6. Right: Riprap bank on river-left upstream of the bridge crossing in Reach 6.

modifications to the banks resulting in anthropogenically-induced bank instability were observed by the habitat team.

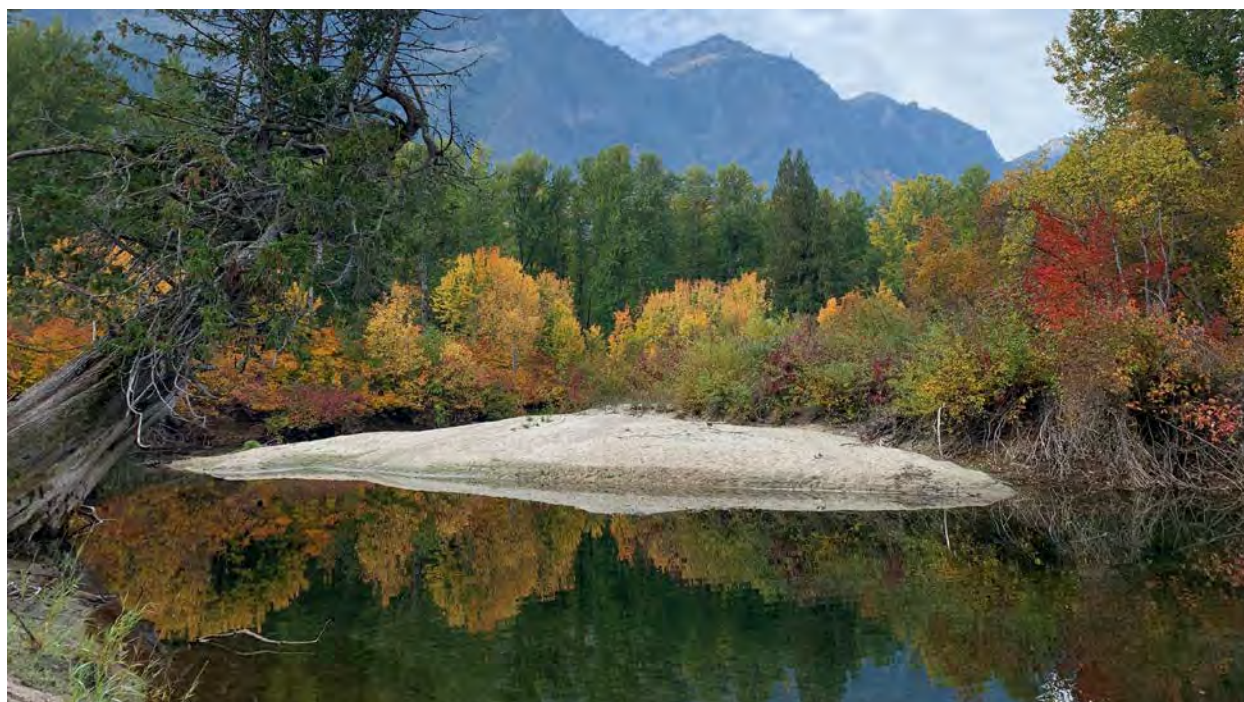
Figure 13. Representative pool observed in Reach 1.

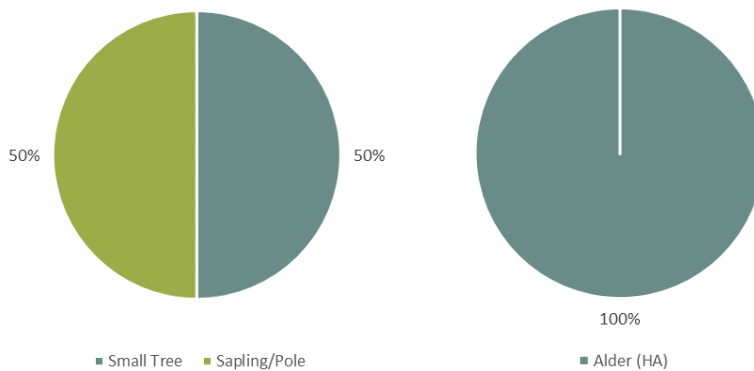
Figure 14. Dominant overstory size class (left) and dominant overstory species (right) for Reach 1.
